Region 9 Enforcement and Compliance Assurance Division

RCRA INSPECTION REPORT PHOTOGRAPH LOG

Apple, Inc. – 08/17/2023, 08/18/2023 and 01/16/2024

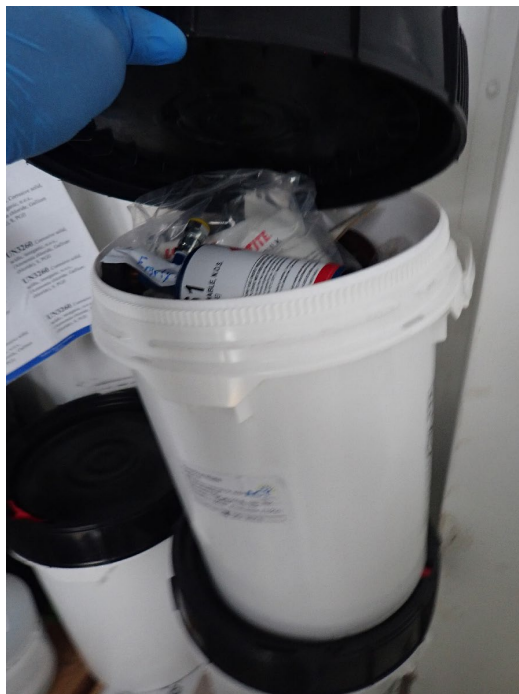
Photograph 2a (P8170013.JPG - 08/17/23): A photo of an open 5-gallon container of "Adhesive Liquids and Tape" waste in Apple's Bunker Area. The lid of the container was not secured, and the waste was being managed as non-RCRA hazardous waste.

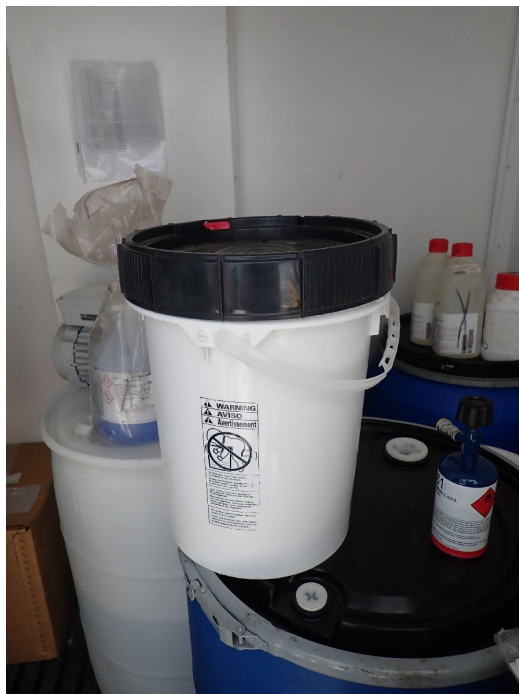
Photograph 2c (P8180013.JPG - 08/18/23): A close-up photo of the closed 5-gallon container of “Adhesive Liquids and Tape” waste in Apple’s Bunker Area. The container was closed on 08/18/23.

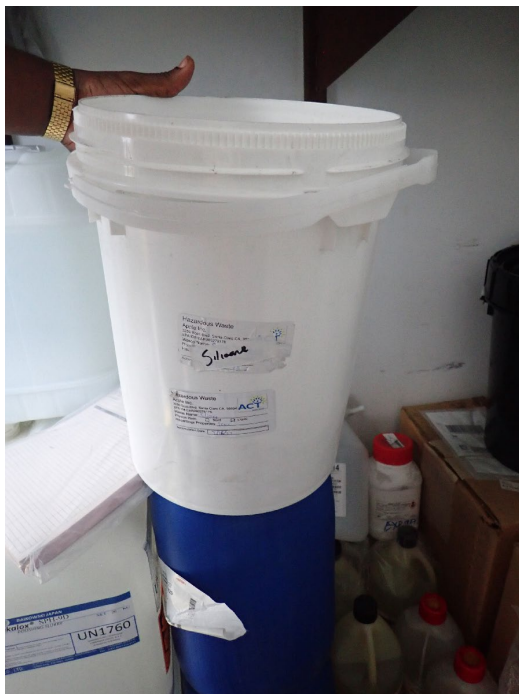
Photograph 3a (P8170015.JPG - 08/17/23): A photo of a 5-gallon container of “Silicone” waste in Apple’s Bunker Area. The container was closed but had an ASD of 03/16/22, more than 90-days from the date of EPA’s inspection. This waste was regulated as a non-RCRA hazardous waste.

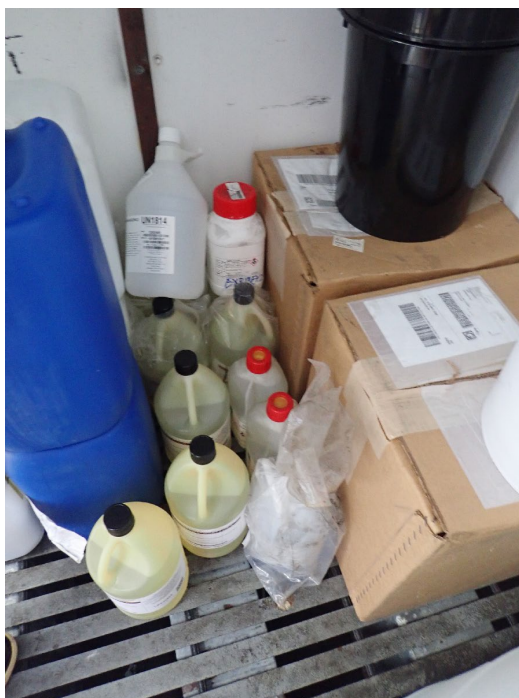
Photograph 4a (P8170016.JPG - 08/17/23): A photo of several containers of expired chemicals on the floor of Apple’s Bunker Area. According to the facility representative, the containers were placed in the Bunker Area that morning and hadn’t been properly labeled with a hazardous waste label or dated, prior to EPA’s arrival.

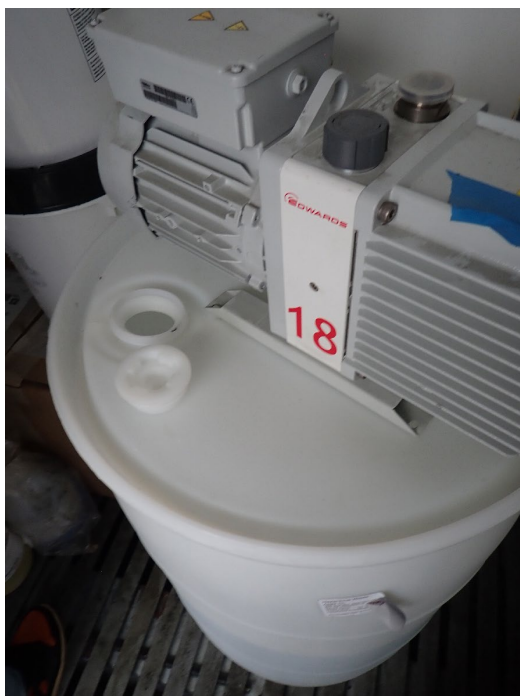
Photograph 5a (P8170020.JPG - 08/17/23): A photo of an open 55-gallon container of “Mega Posit” in Apple’s Bunker Area. At the time of the inspection, the cap was laying on top of the opening of the container (not as depicted here). According to Apple, the container was left opened in order to prevent the container from expanding and bulging.

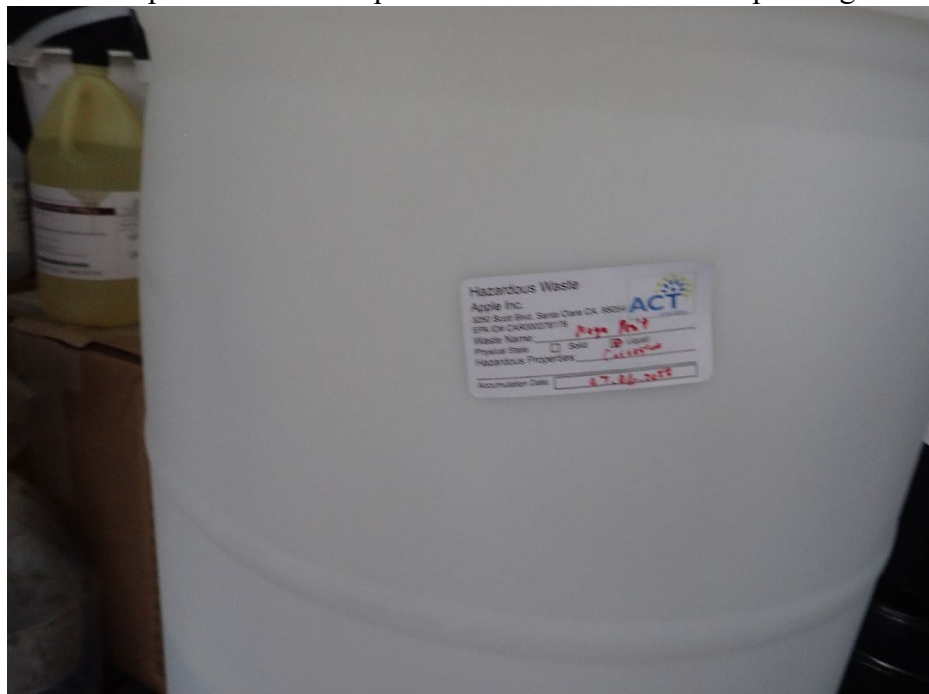
Photograph 5b (P8170021.JPG - 08/17/23): A close-up photo of the label on the open 55-gallon container of “Mega Posit” waste in Apple’s Bunker Area. The label was starting to peel off of the container while inside the Bunker Area.

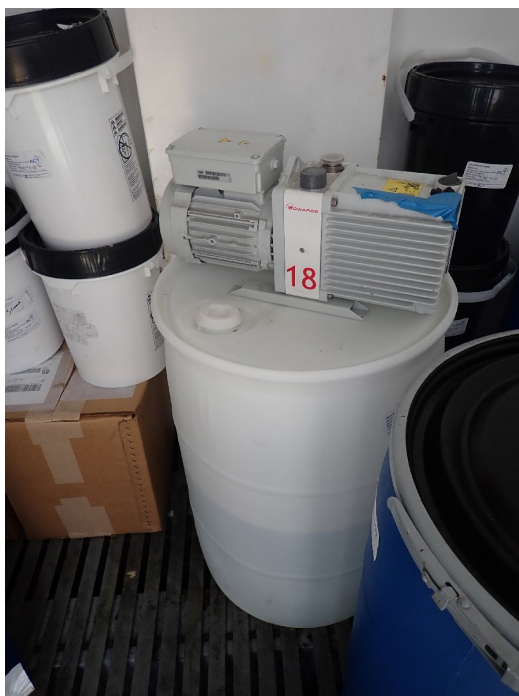
Photograph 5c (P8180012.JPG - 08/18/23): A photo of the cap placed back on the container, officially closing the container. This container was documented as closed on 08/18/23.

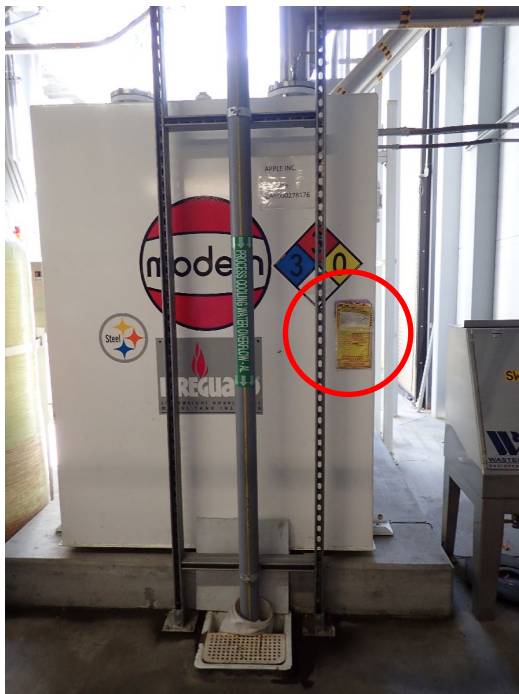
Photograph 6a (P8170051.JPG - 08/17/23): A photo of Apple's 1,700-gallon stainless-steel hazardous waste tank. The tank was marked with the words, "Hazardous Waste" and used for the accumulation of spent solvent waste. At the time of the inspection, the solvents were being managed as California Only Waste.

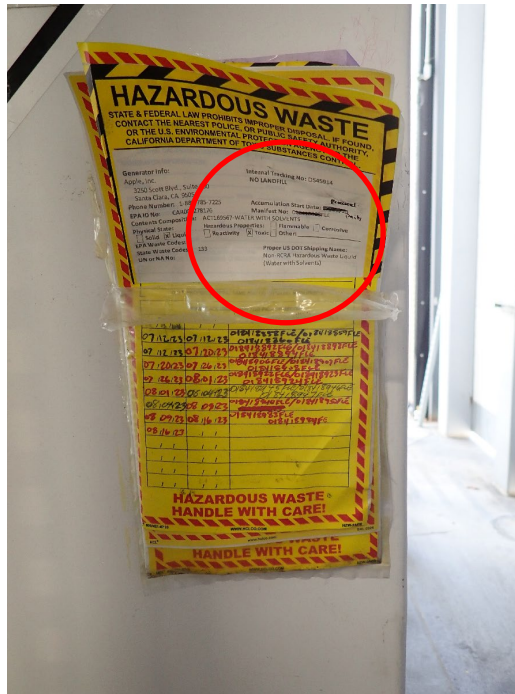
Photograph 6b (P8170052.JPG - 08/17/23): A photo of The hazardous waste label on the 1,700-gallon solvent waste tank in the Bunker Area. At the time of the inspection, the waste was marked as “Water with Solvents” and managed as California Only Waste.

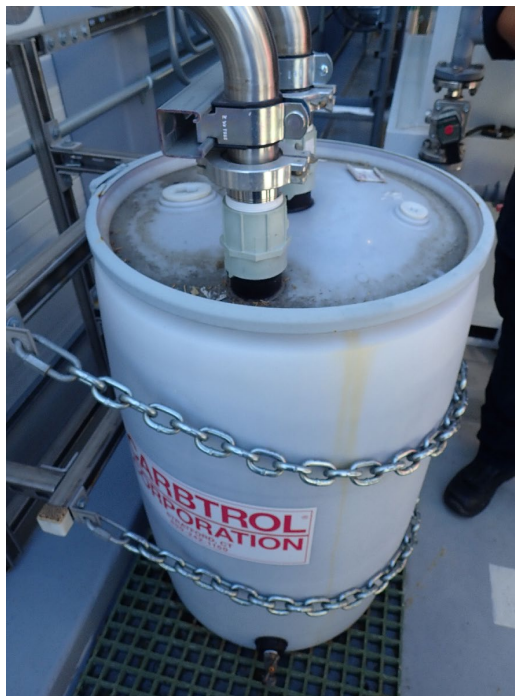
Photograph 7a (P8170062.JPG - 08/17/23): A photo of a 55-gallon container filled with “Activated Carbon” and located on the roof of Building 1. This drum is used to capture the VOC emissions from Apple’s 1,700-gallon spent solvent waste tank. The container was not labeled or identified in Apple’s air permit or their RCRA tank assessment.

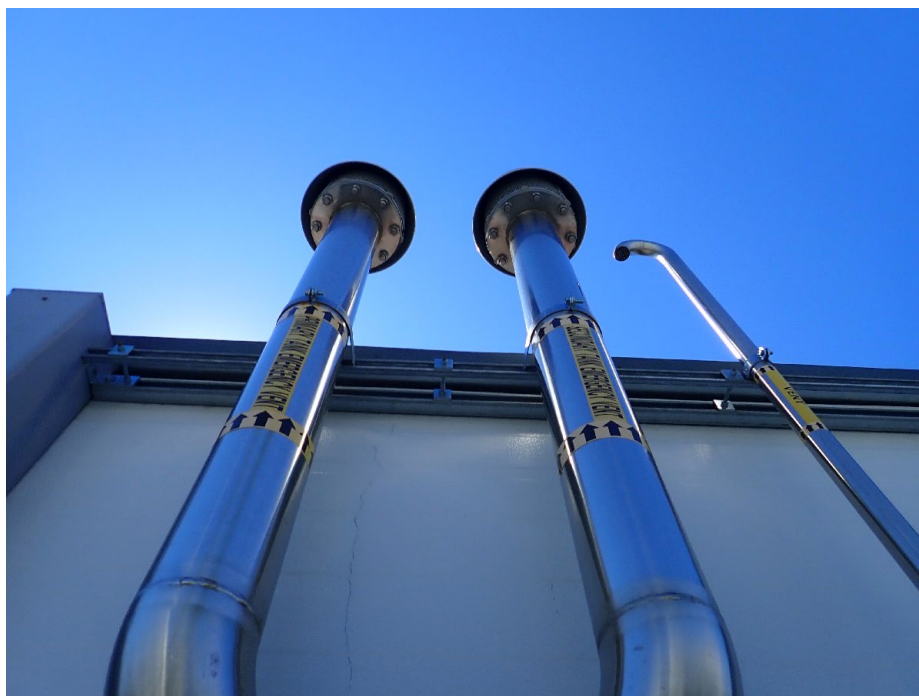
Photograph 7b (P8170061.JPG - 08/17/23): A photo of three vents connected to Apple’s 55-gallon container filled with “Activated Carbon”. The two vents on the left are emergency vents for the double-walled tank. The vent on the right is the main vent.

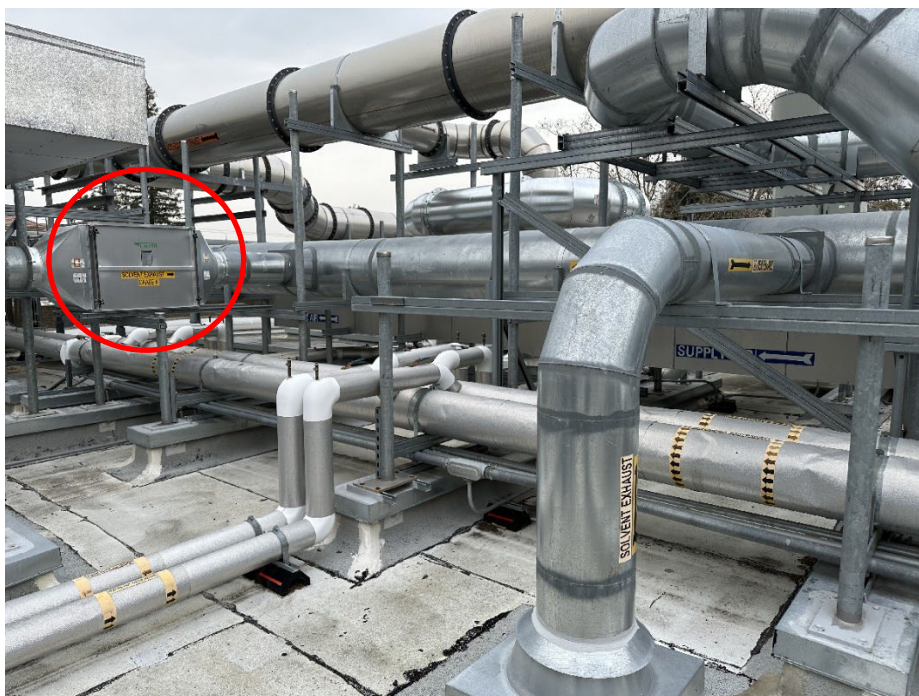
Photograph 11b (IMG_5589.JPG - 01/16/24): A photo of Apple's solvent exhaust system on the right ([REDACTED]) emerging from the ceiling in the [REDACTED] Area and connecting to the larger exhaust system piping on the roof. The "Activated Carbon" box for [REDACTED] is located on the left side of the photo, which is used to vent VOCs.

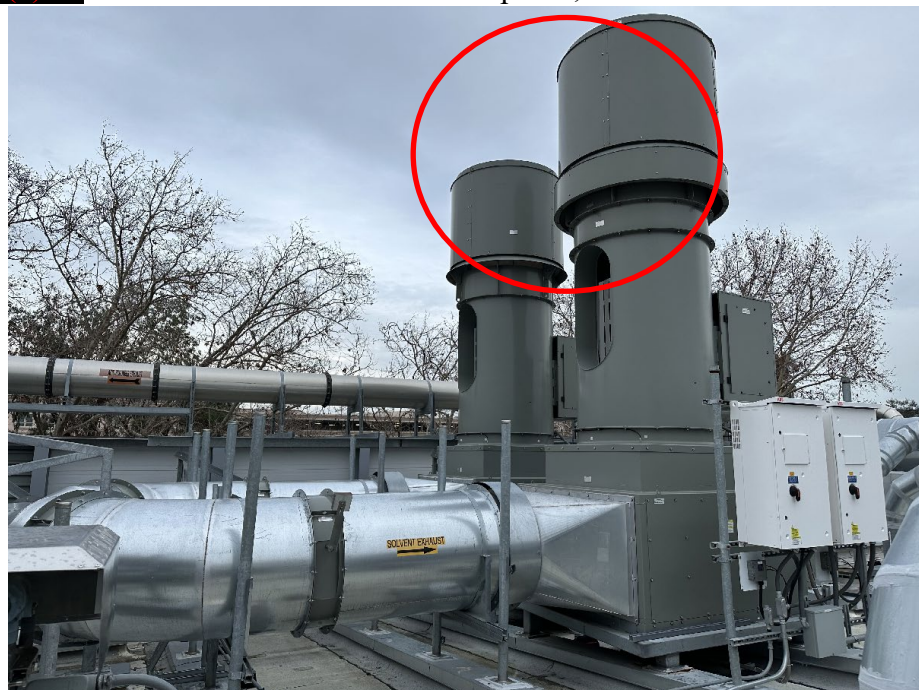
Photograph 11c (IMG_5591.JPG - 01/16/24): A photo of Apple's solvent exhaust piping connecting to one of the main general exhaust systems on the roof of Building 1. The general exhaust system vents the air directly to the atmosphere.

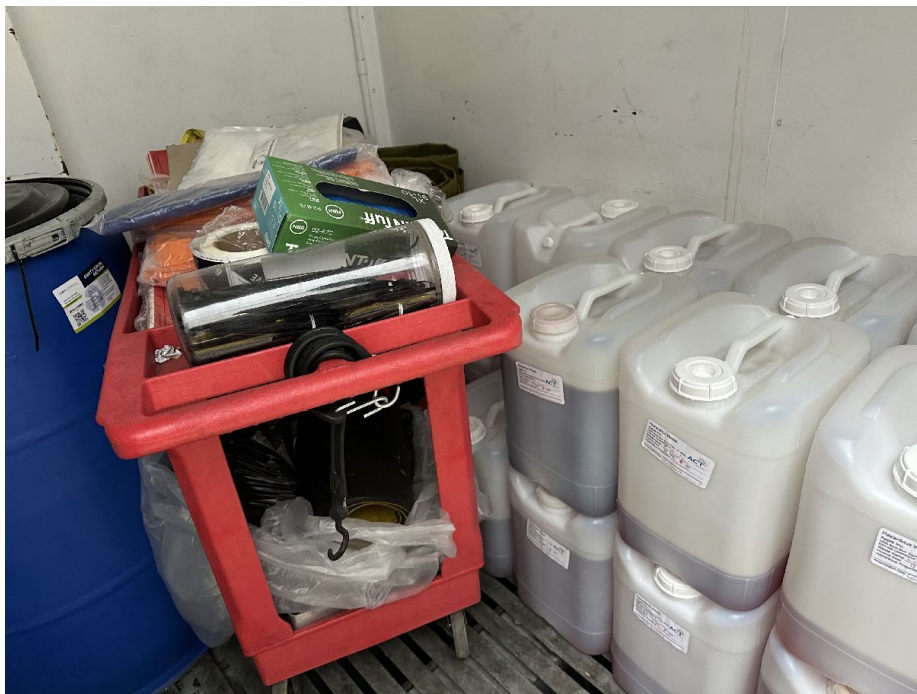
Photograph 13a (IMG_5594.JPG - 01/16/24): A photo of twelve 5-gallon containers of mixed solvent waste in Apple's Bunker Area. The labels on eight of the twelve containers were not clearly visible during the inspection. The waste from these containers were accumulated upstream in Apple's **B(4)** Area.

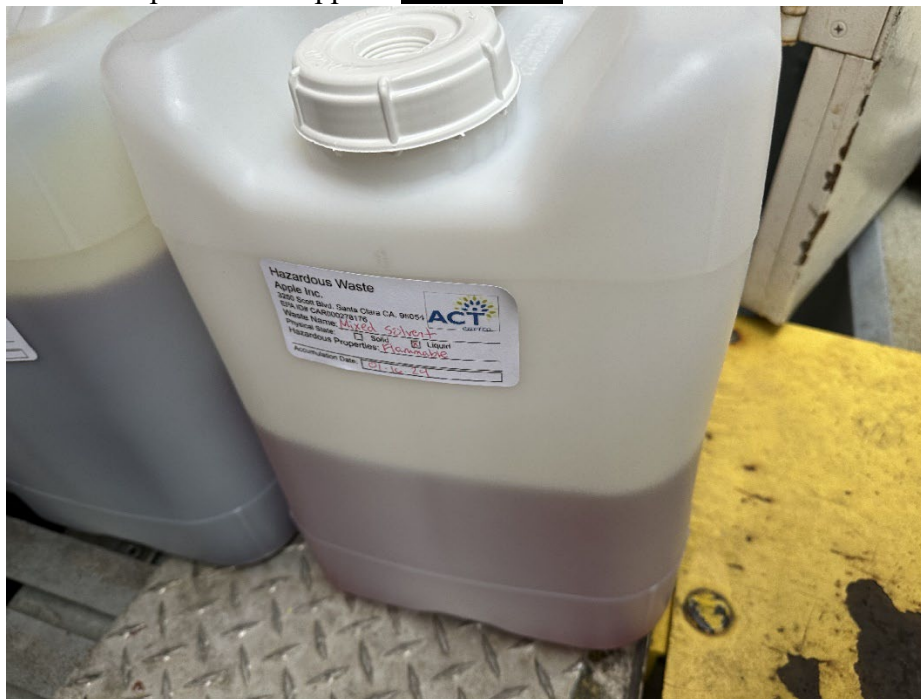
Photograph 13b (IMG_5598.JPG - 01/16/24): A photo of one 5-gallon container of mixed solvents in Apple's Bunker Area. The container is marked as a flammable waste (D001 Waste) and has an accumulation state date of 01/16/24.
